Van Duzen River Watershed Analysis

Cumulative Watershed Effects

Final Report

**TETRA TECH, INC.**
Arcata, CA

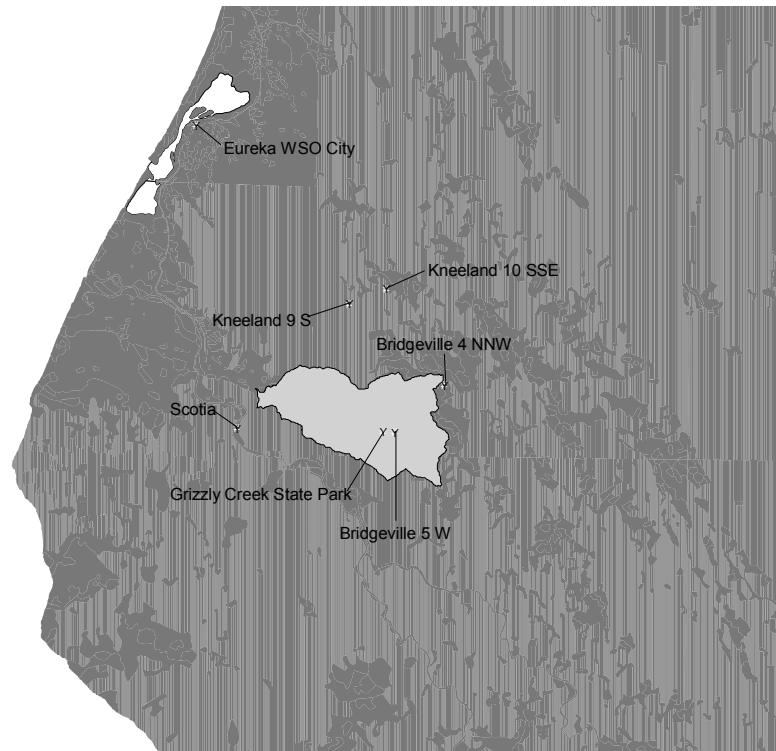
Figure 2-4. Climate Stations in the Vicinity of the Van Duzen Watershed Analysis Unit

Daily snowfall records are available for several stations in the vicinity of the analysis area (Table 2-9, Figure 2-4). Figure 2-7 shows mean monthly snowfall at the Scotia, Grizzly Creek State Park, and Bridgeville 4 NNW stations.

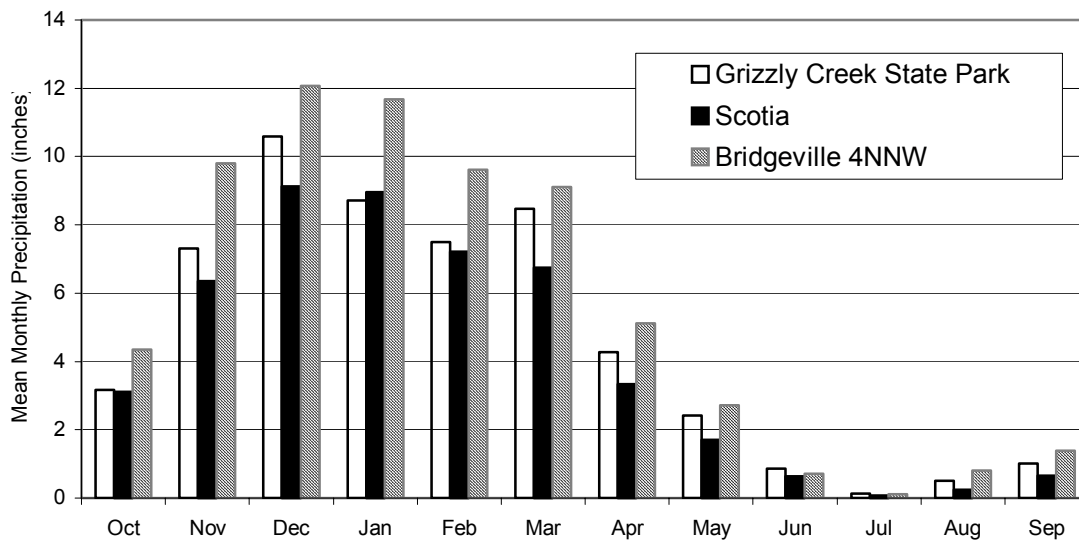
Figure 2-5. Mean Monthly Values for Observed Precipitation at Several Climate Stations in the Vicinity of the Analysis Unit (refer to Table 2-9, Figure 2-4 for locations), and estimated PRISM values for the Van Duzen Watershed Analysis Unit

The area-weighted mean annual precipitation for the analysis area is 55 inches. Precipitation data from the Grizzly Creek State Park Weather Station located within the study area indicate that mean monthly precipitation values range from 0.13 inches for the month of July to 10.58 inches for the month of December. Precipitation amounts vary within the watershed, and roughly correlate with elevation. For example, estimated mean annual precipitation in VANM HAU (exclusive of upstream areas) at the downstream end of the study area is only 47 inches, as compared with 68 inches for the higher elevations of the Grizzly Creek sub-basin. Monthly precipitation amounts follow similar patterns.

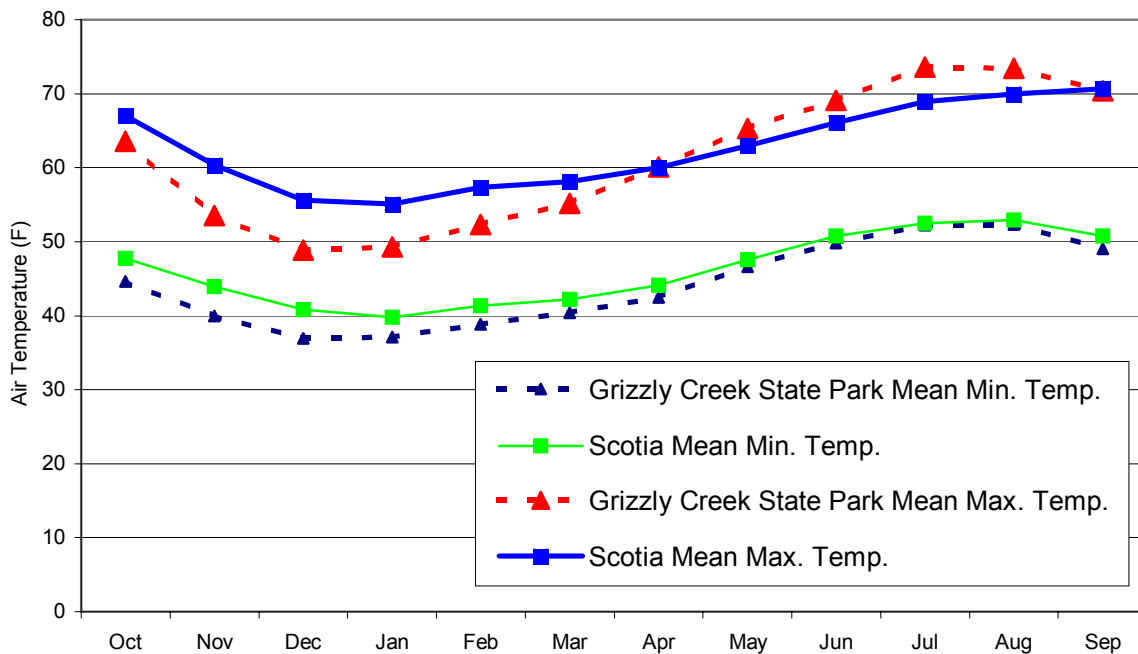
Figure 2-6. Mean Minimum and Maximum Monthly Air Temperatures at Stations near the Analysis Unit

Air temperatures in the North Coast area are moderate and the annual fluctuation is one of the smallest in the conterminous United States (NOAA 2000). Seasonal air temperature variation is small due to the close proximity to the Pacific Ocean. The prevailing northwest winds cross cold upwelling waters usually present along the along the Humboldt County coast. Mean minimum temperature in Scotia for the month of January is 40° F (Figure 2-6), and the coldest low temperatures in a typical winter are in the low 30s. Mean maximum temperatures in Scotia for the month of September is 71° F (Figure 2-6), while the highest temperatures are typically in the mid-70s. Inland locations (e.g., Grizzly State Park) experience wider seasonal variation in air temperatures (Figure 2-6).

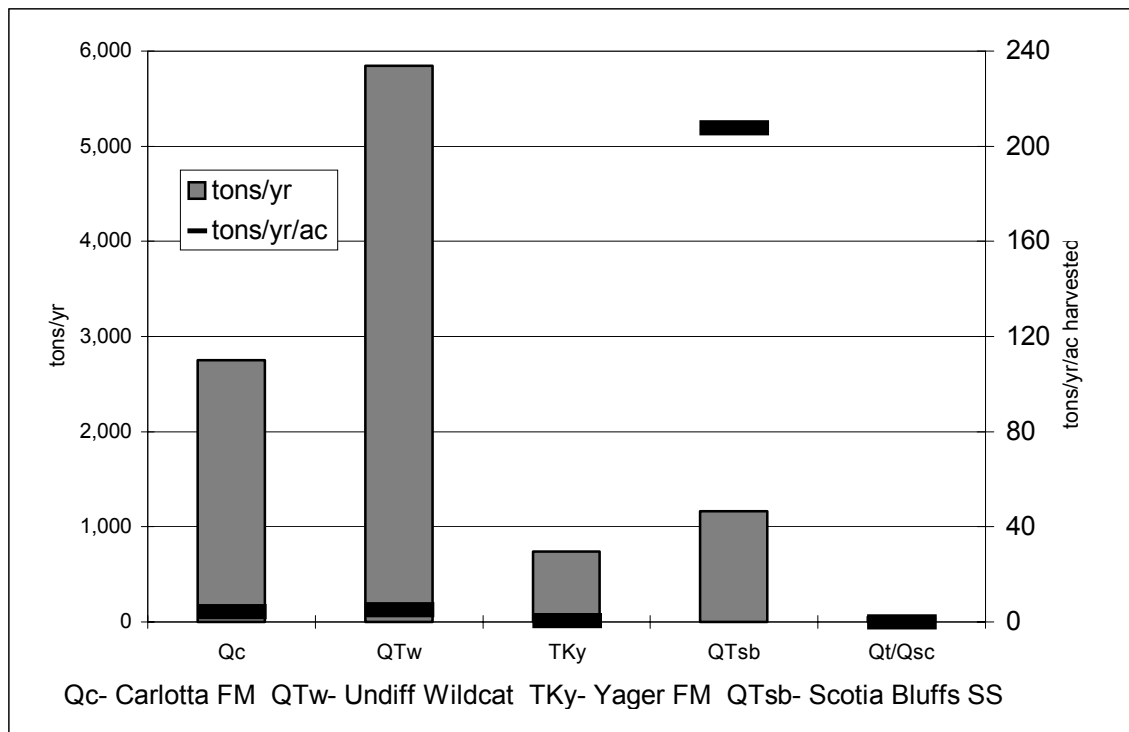
Figure 4-1. Hillslope Landslide Delivery Volumes by Geologic Unit

Hillslope landslide delivery volume is depicted in Figure 4-1 by geologic unit and in Figure 4-2 by sub-basin. As shown, the Scotia Bluffs (QTsb) geologic unit yields the largest rate of hillslope landslide delivery per acre harvested, however, this unit has relatively small acreage. Therefore, it does not contribute significantly to sediment delivery from hillslope landslides as does Undifferentiated Wildcat (QTw). Undifferentiated Wildcat yields the largest hillslope landslide delivery volume due to its large acreage combined with its instability. Scotia Bluffs occurs primarily in the Hely Creek sub-basin, whereas, Root Creek contains the largest percentage of Undifferentiated Wildcat compared to other sub-basins.

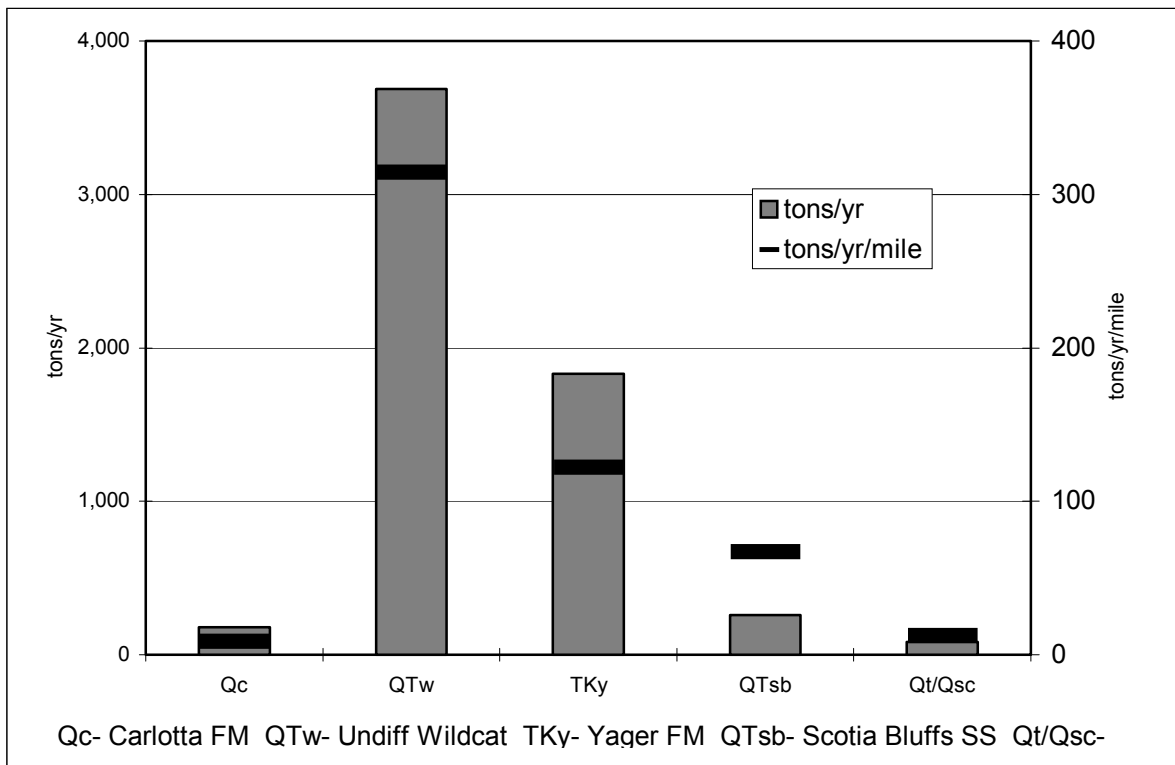
Figure 4-3. Road-Related Landslide Delivery Volumes by Geologic Unit

Road-related landslide delivery volume is depicted in Figure 4-3 by geologic unit and in Figure 4-4 by sub-basin. As shown, the Undifferentiated Wildcat (QTw) geologic unit yields the largest rate of road-related landslide delivery rate per mile of road. It should be noted that the largest road-related delivery volume also occurs in this geologic unit due to its large number of road miles. The Hely Creek sub-basin yields the most road-related landslide sediment delivery because of its large proportion of Undifferentiated Wildcat along with the large network of roads.

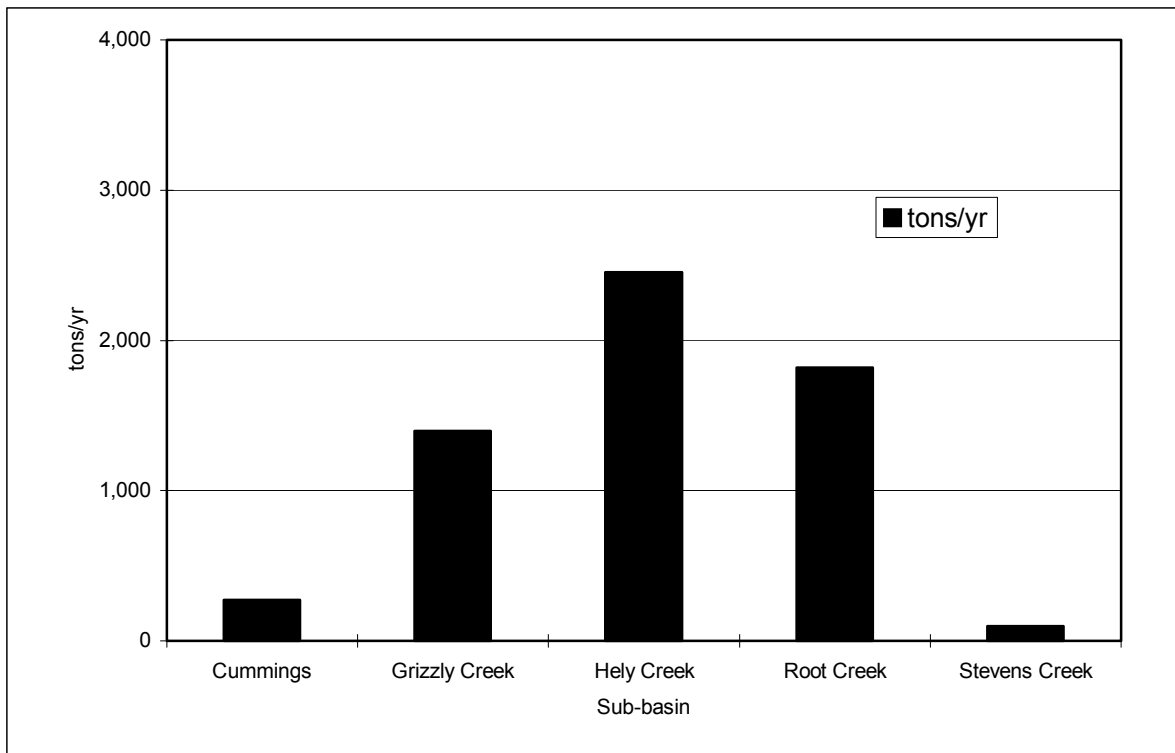
Figure 4-4. Road-Related Landslide Delivery Volumes by Sub-basin

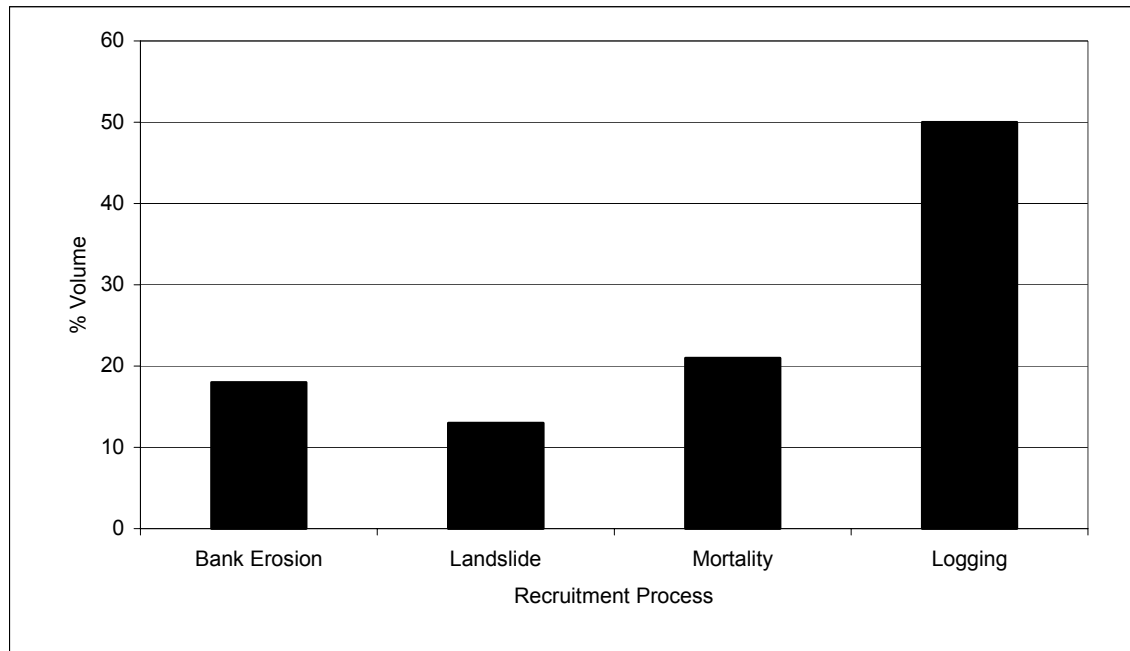
Figure 4-6. Large Woody Debris Recruitment for All Van Duzen Study Sites

streams) yields 90% of wood from within 10 meters from the channel; and (2) streamside landslide recruitment (steeper gradient streams) yields 90% of wood from within 30 meters from the channel.

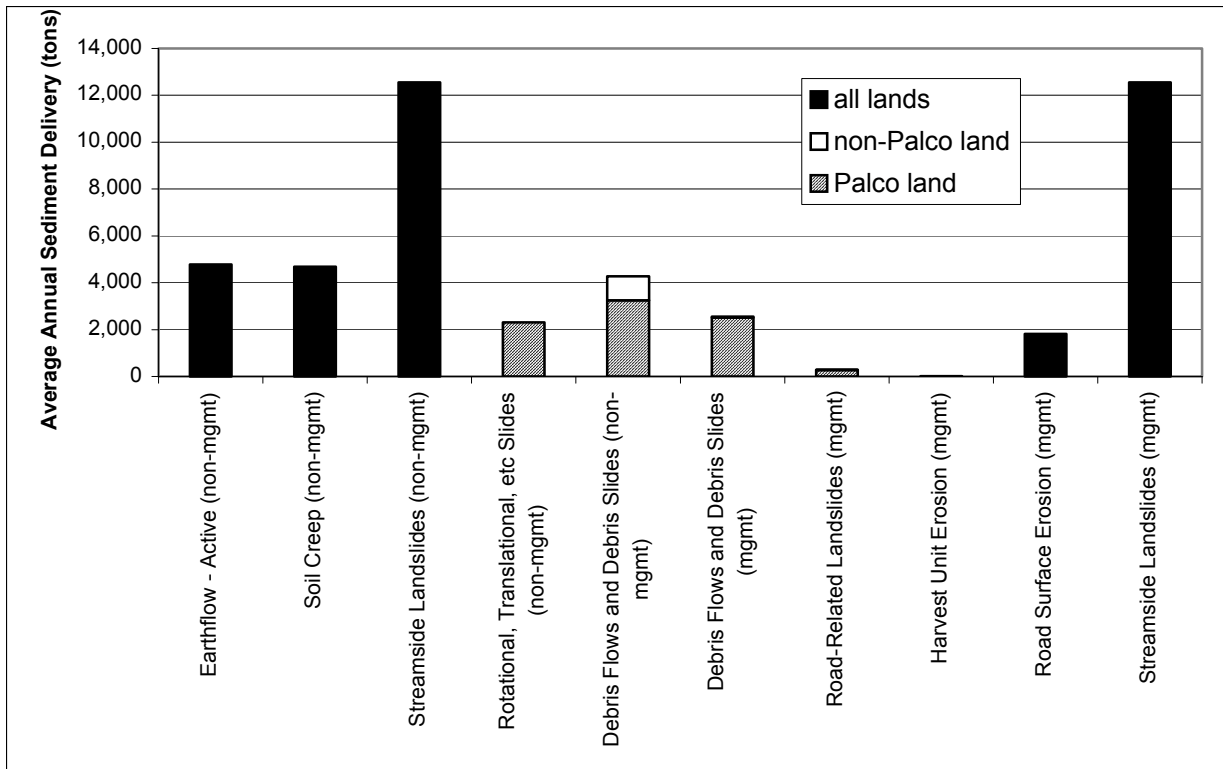
Figure 5-2. Cummings Creek Sub-Basin Sediment Source Delivery to Streams

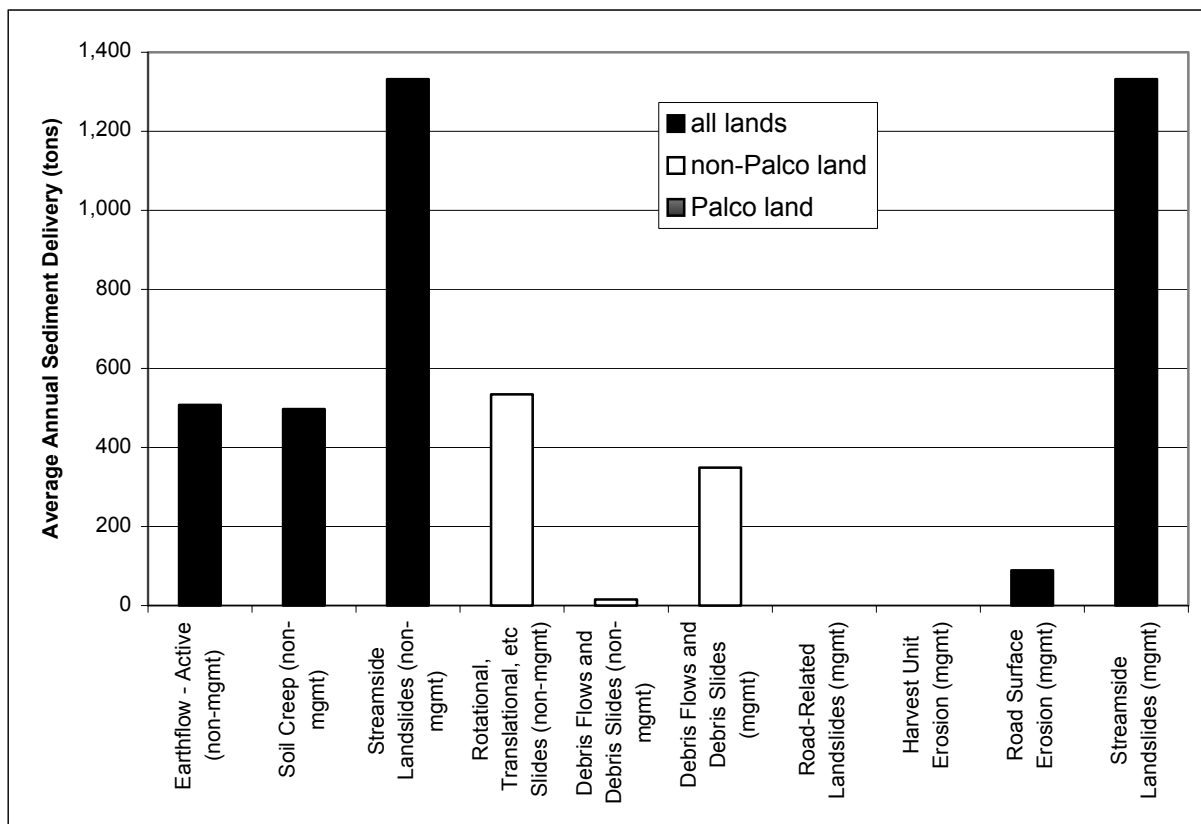
Figure 5-5. Hydesville Creek Sub-Basin Sediment Source Delivery to Streams

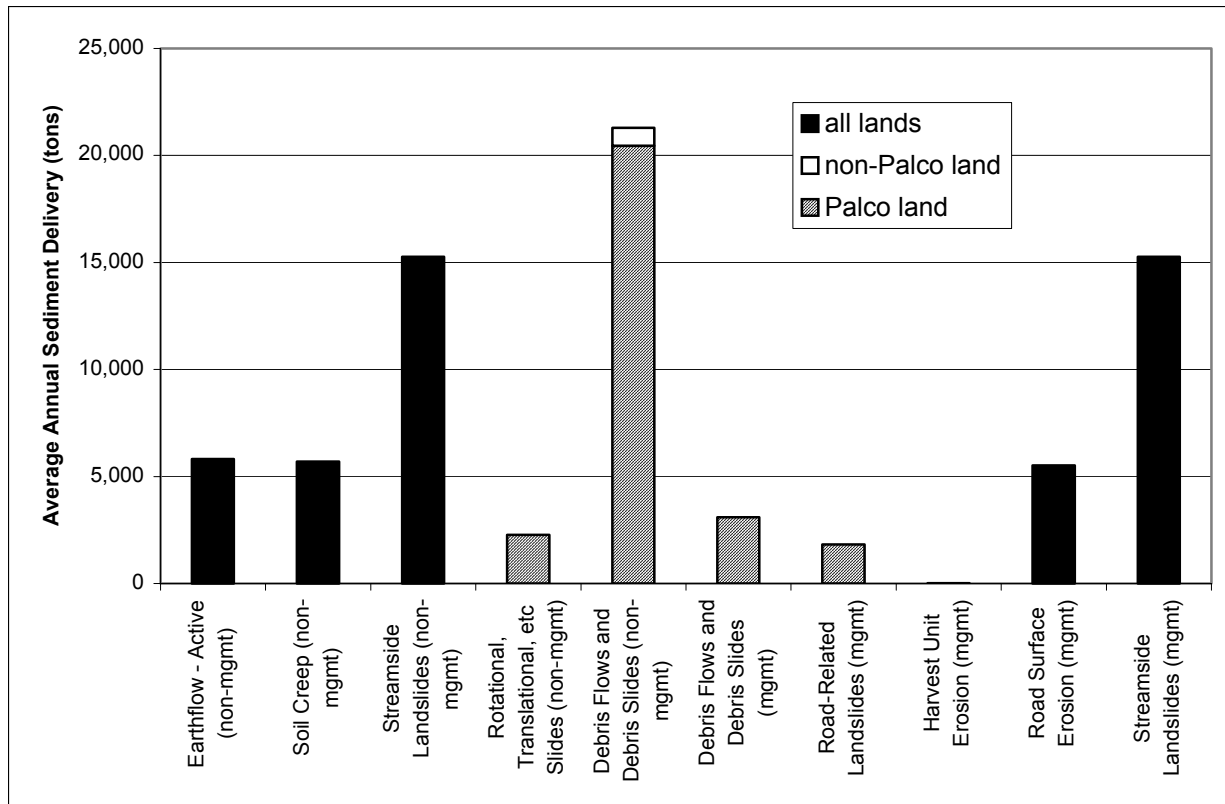
**Figure 5-6. Root Creek Sub-Basin
Sediment Source Delivery to Streams**

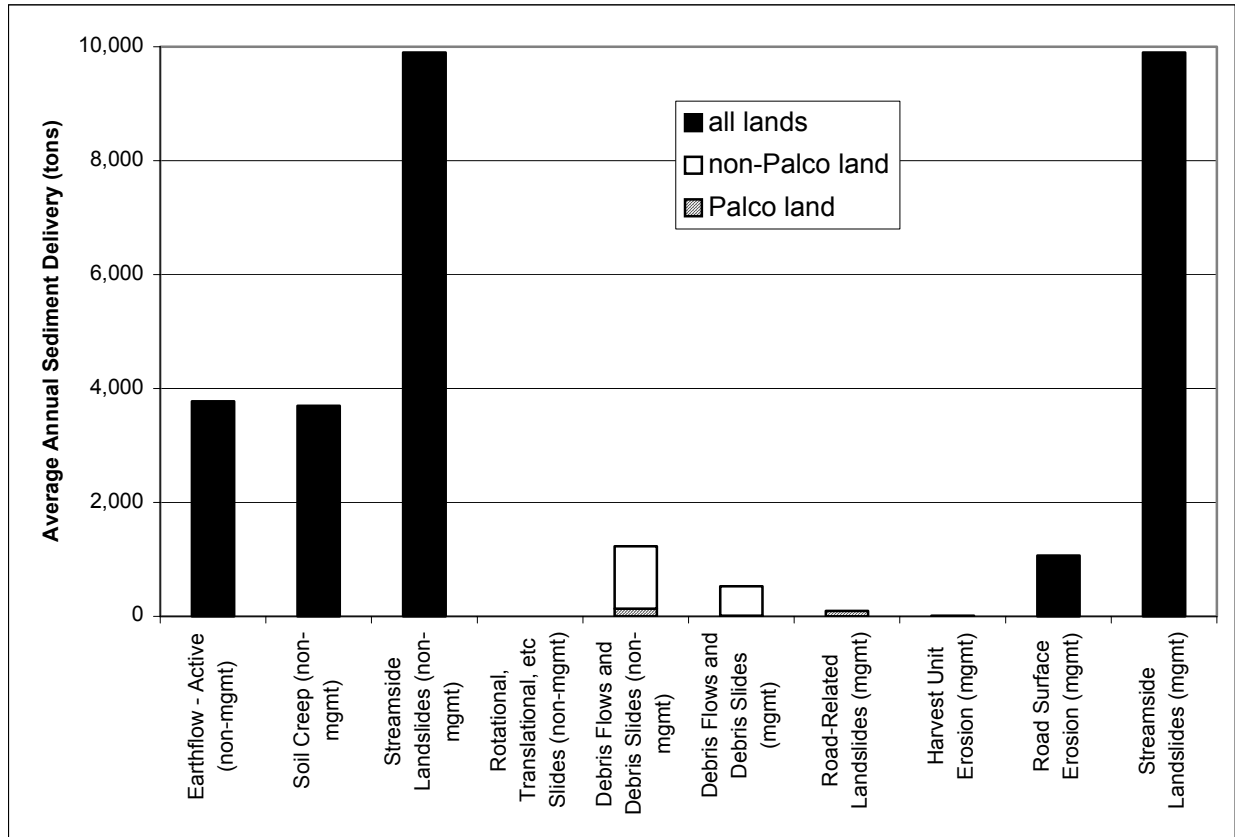
Figure 5-7. Stevens Creek Sub-Basin Sediment Source Delivery to Streams
